Report from a UK incident

Loss of control of well logging source being transferred from a transport container

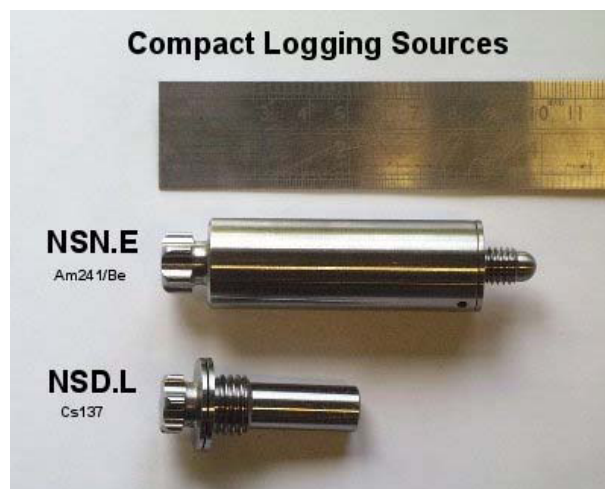
Photograph of typical well-logging sources

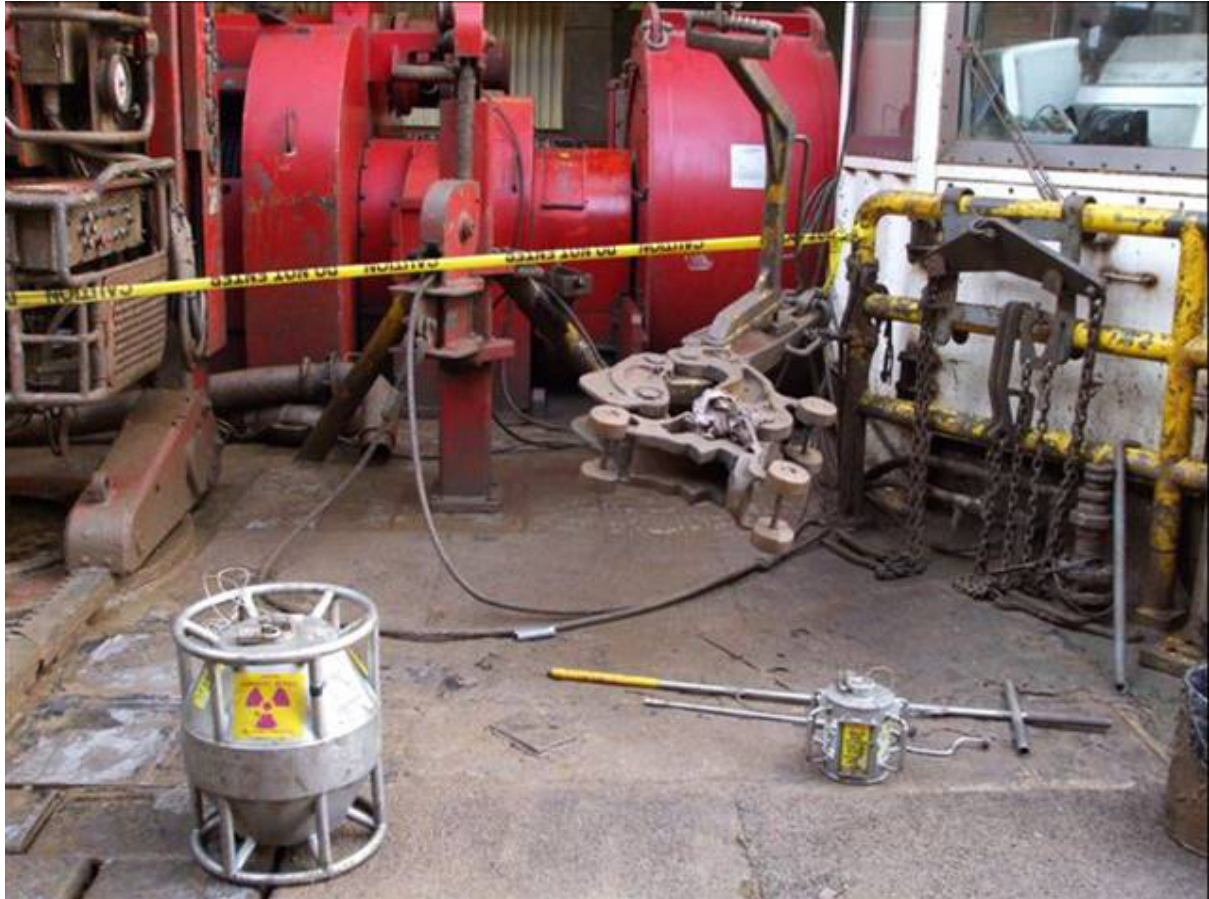
Photograph of oil platform showing typical well-logging transport containers and source transfer tools
