Report from a UK incident

Inadvertent disposal of radioactive source used in a textile factory gauge

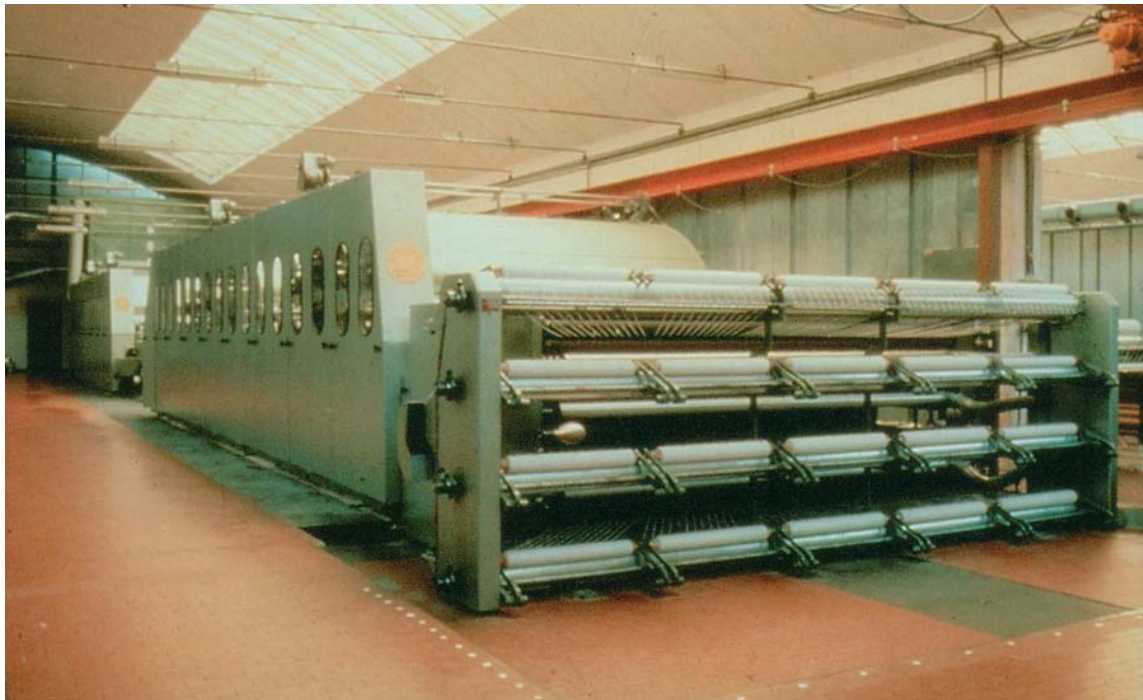
A typical carding machine that the gauge would have been installed in

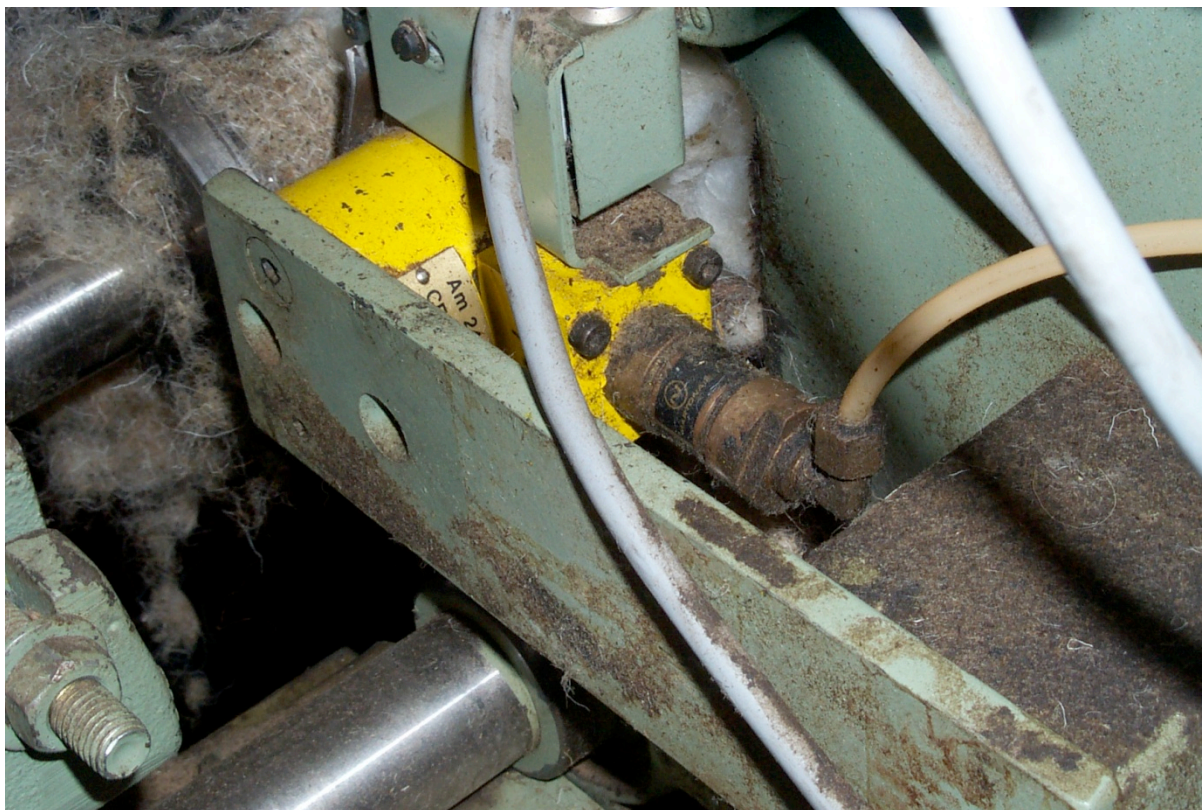
During a routine visit to check on progress with the decommissioning of a carding machine (see picture for a typical example), a company's senior engineer discovered that an 11.1 GBq americium-241 source that should have been installed on the production line was missing. The carding machine, used in the textile industry, had not been used for approximately six months. The senior engineer reported the discovery to the site's Engineering manager and was informed that the gauge containing the source had been removed from the machine and placed in a store approximately six months previously. The visiting engineer asked to see the source in the store and immediately noticed that it was the detector not the source that had been placed in the store. Further investigation revealed that the Engineering Manager at the site where the source had been installed had been instructed by the Site Manager to remove the source and place it in storage prior to decommissioning of the production line. The Engineering Manager had not received training in the operation of the gauge or in radiation protection and mistakenly thought that the detector was the part of the gauge that contained the radioactive source. He therefore removed the detector and placed it in the store. The source and its housing remained attached to the machine which was sent for scrap metals recycling.

Close up of source housing. Radiation beam directed towards a detector at the far side of the line.

The regulations require companies that use radioactive material to appoint and train employees to provide effective supervision of those radioactive sources. In particular, regular checks on the location of radioactive sources must be made, with written records of the checks made. Suitable and sufficient risk assessments must be carried out before work commences and employees carrying out that work must have received the information, instruction and training necessary to ensure that they are competent to carry out their duties. In most cases, the employer is also required to seek expert advice on compliance with the regulations.
