## Report from a UK incident

### Road density gauge crushed by road roller

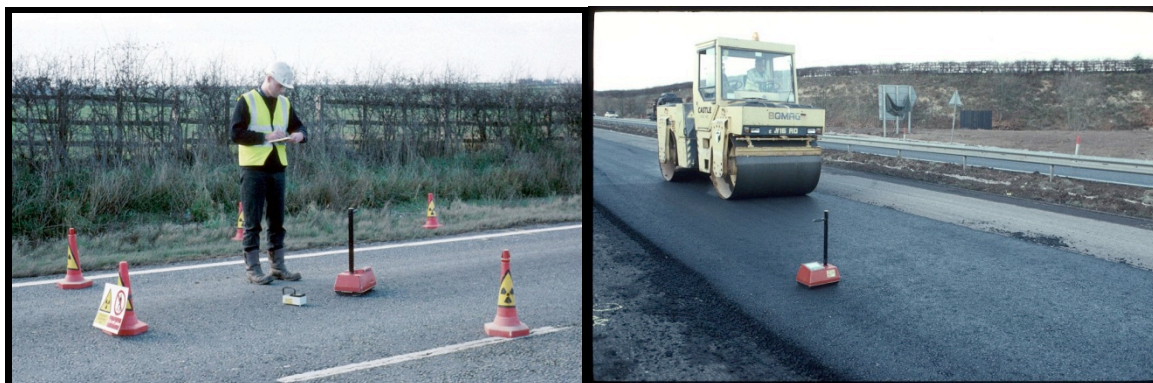
**Nuclear density gauge in use risks...**

**All users on site must be aware of the**

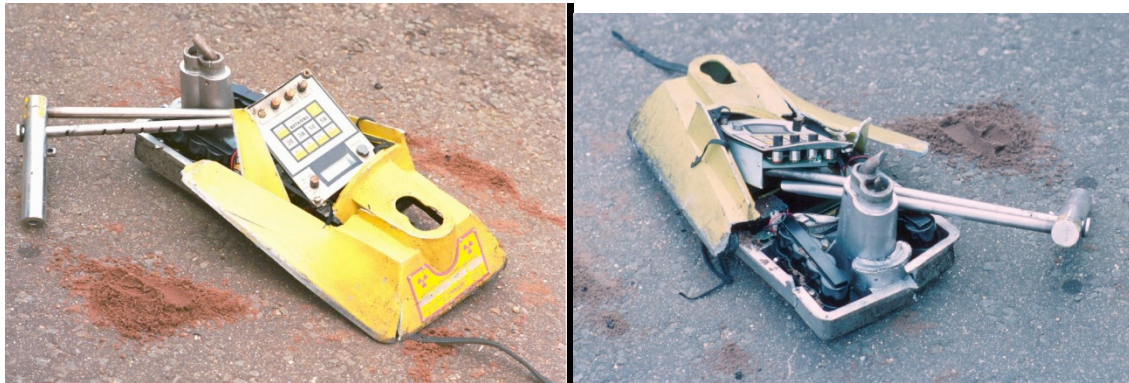
A portable density gauge, belonging to a road construction company, was badly damaged when it was crushed by a road roller. This type of gauge, which incorporates a 370 MBq caesium-137 source and a 1.85 GBq americium/beryllium source is commonly used in road construction.

The gauge was left in the road whilst the operator discussed his work with a supervisor on the nearby footpath. The driver of the road roller did not see the gauge as he traversed the site. He was alerted to the situation by the gauge operator, but was unable to stop the roller in time. The operator cordoned off an area up to five metres around the damaged gauge and called for assistance.

**Damaged gauge after being run over by road roller      However, the source capsules were not damaged during the incident**

Despite the severe damage to these gauges, the source capsules remained intact, and there was no radioactive contamination.

- Operators of nuclear density gauges must be aware of their supervisory duties and not leave a gauge unattended unless it is securely stored in a building or vehicle. This is particularly important when large vehicles are in the vicinity.

- Consideration should be given to temporarily demarcating an area around the gauge (eg with suitable labelled traffic cones or a flashing beacon), where the supervision of the operator is not considered sufficient to prevent incidents such as those above.

- If a nuclear density gauge is badly damaged, it should not be immersed in material such as sand or stones since this obstructs a proper assessment of the damage. It may in fact make the situation worse if a radioactive source is ruptured, ie because any material placed in contact with the gauge could become contaminated. Instead, the area around the gauge (2 metres is normally sufficient) should be demarcated and the gauge should not be touched until it has been examined and checked for leakage of radioactive material.
