## Report from a UK incident

### Source fell out of shielding container – level gauge in a quarry

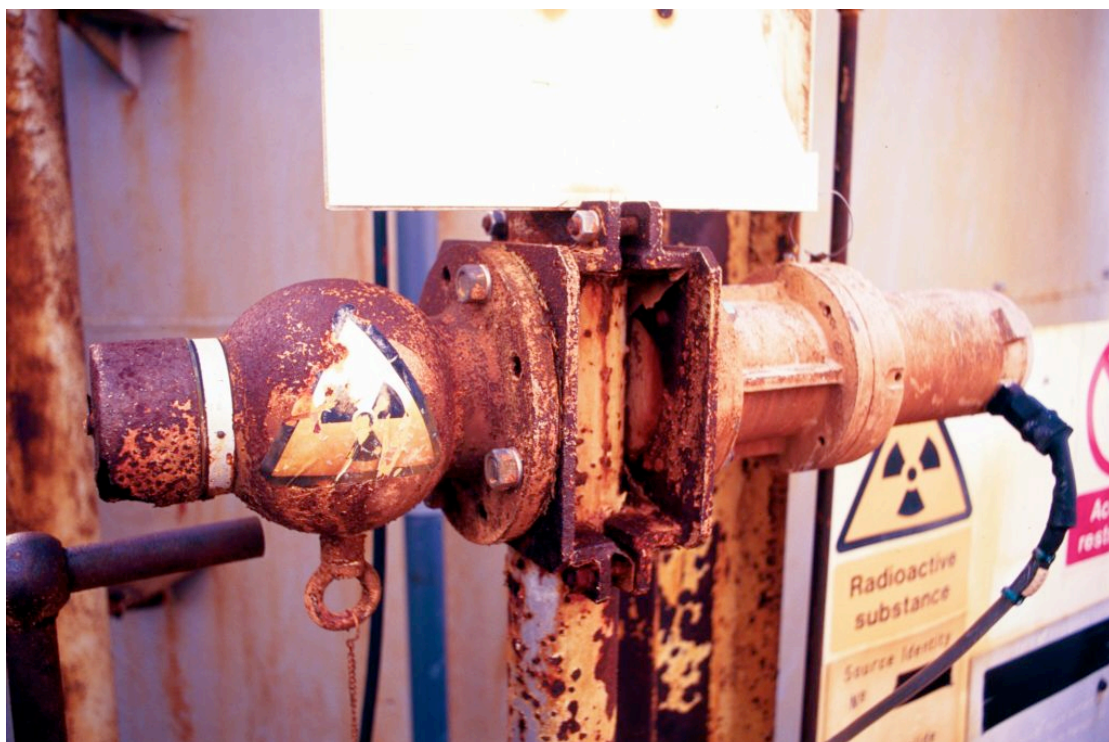
Investigations found that the cover to the source housing had become loose over time, as it was installed on equipment that was subject to vibration. The cover was normally held in place by two bolts and when these became loose the source was able to fall out. The plant operator was not aware that the equipment was radioactive, or of the risks of picking it up as he had not received any training and was not aware of the local rules.

1. The suppliers of the gauge should have ensured it was fit for purpose and designed in such a way as to prevent the bolts working loose.
2. The site should have ensured that source location checks included a check of the condition of the gauge. Remedial work should have been carried out before the gauge became loose and the source was able to fall out.
3. All staff working in the vicinity of equipment containing a source of radiation should receive awareness training concerning the potential risks. They should also have been asked to read the local rules. In particular, they should be made aware of the contingency plans and the importance them being properly implemented should any defect or other incident arise.
