## Report from a UK incident

### Inadvertent exposure to persons in vehicle x-ray inspection facility

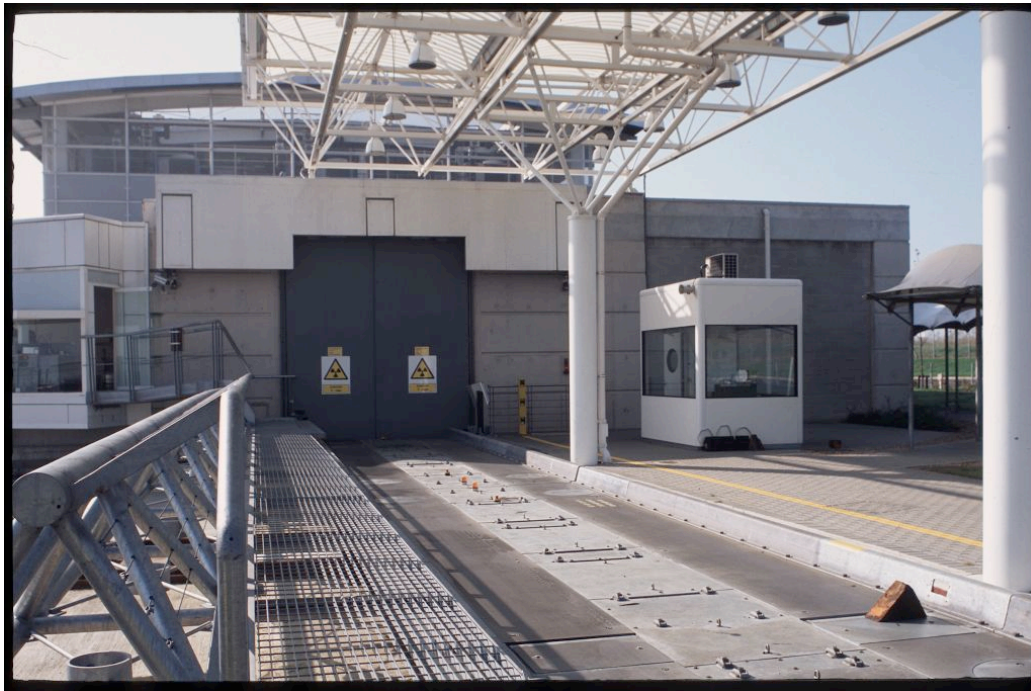
## **Security X-ray facility is used for detecting explosives in freight vehicles**
