## Report from a UK incident

### Contamination of brewery premises during source removal

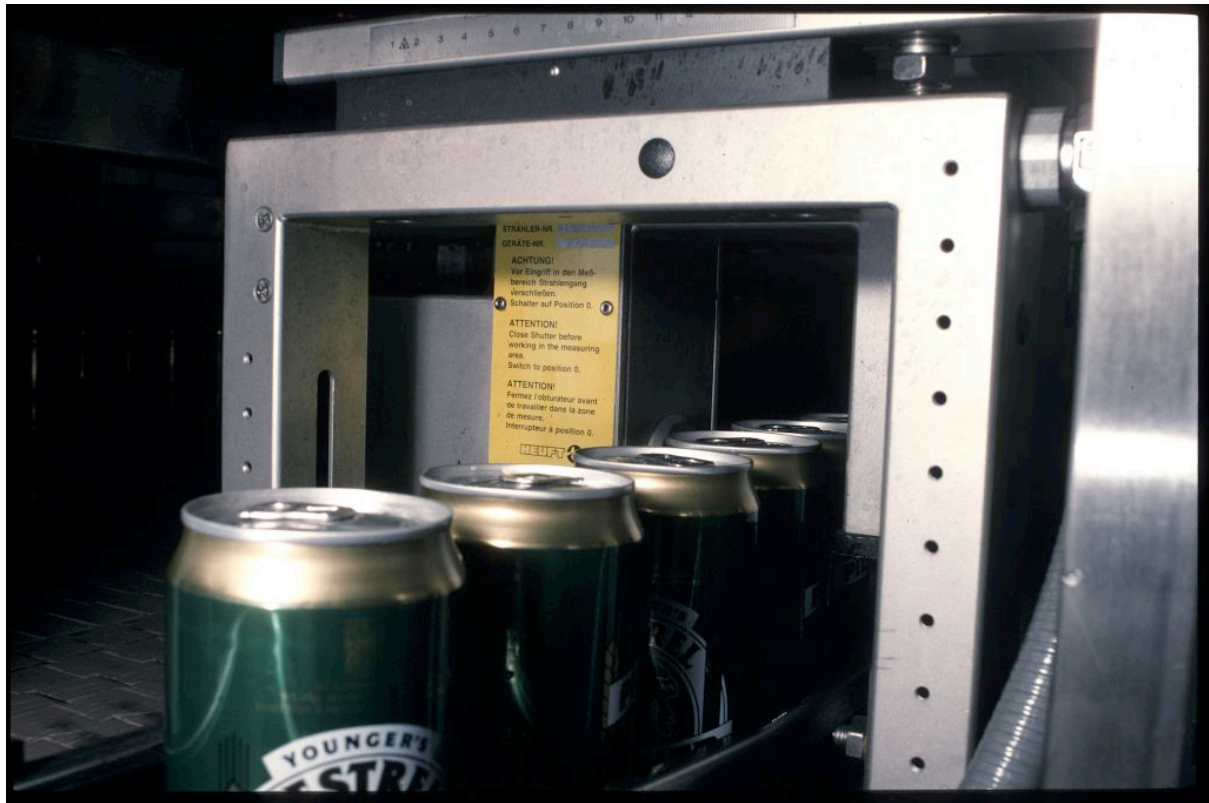
**A typical liquid level gauge in use**

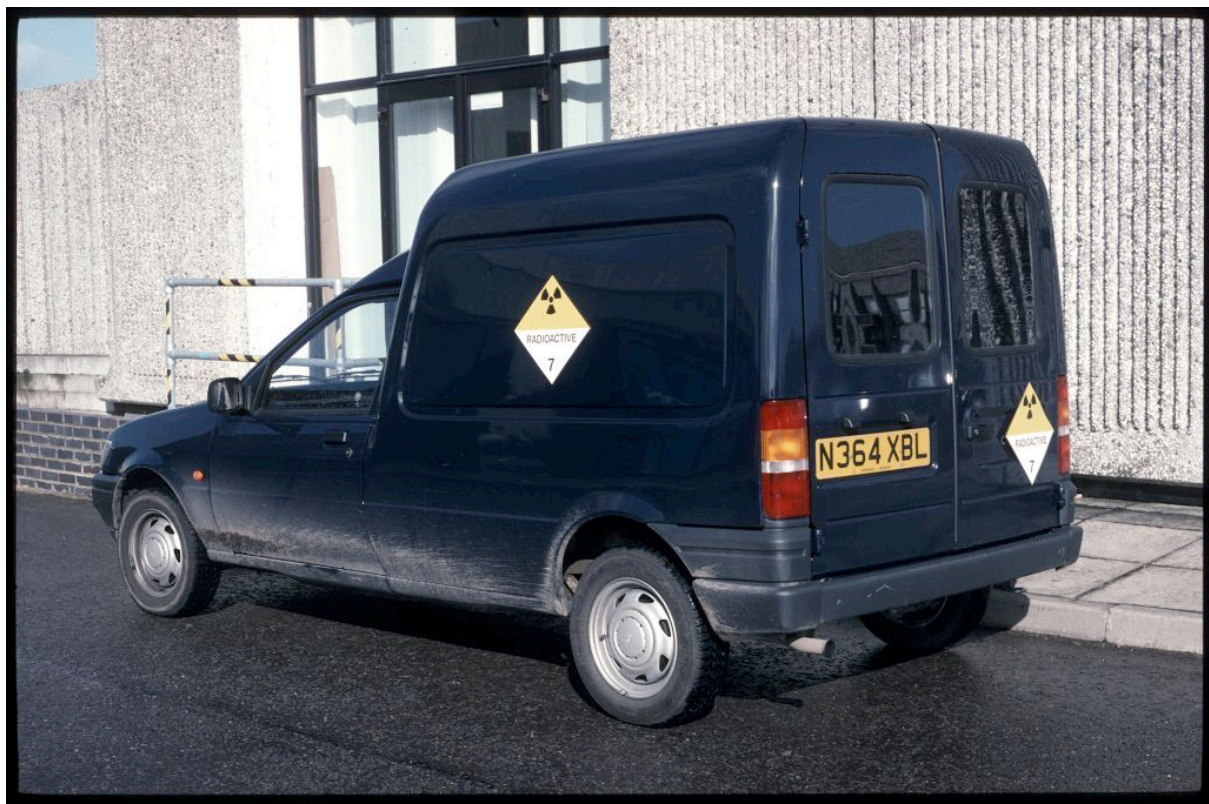
A few days later, it was discovered that both the container and the van itself were significantly contaminated with americium-241. Subsequent monitoring revealed that the contamination was rather more extensive, and included other vehicles and properties. The latter included the original brewery car park, subsequent places visited and the home of one of the workers. The company reported the incident and a detailed investigation commenced.

- The contractor did not discuss the job with the brewery or its Radiation Protection Adviser and had inaccurate information about the size of the gauges;
- Alternative methods of work had not been considered; and
- There was doubt about whether the available radiation monitoring instrument was capable of being used – when the batteries of the radiation monitor were checked some days later these were found to be flat.

**The gauge heads were dismantled in the back of a small van in the brewery car park (note: not the actual vehicle shown above).**

1. Equipment holding radioactive sources should, wherever possible, be transported with the source undisturbed to suitable facilities before dismantling takes place.

2. Where removal of sources on site is unavoidable, close liaison between the companies (and their respective RPAs) should take place with a view to ensuring that adequate facilities are available for the work to proceed safely.

5. After source manipulations appropriate monitoring should be undertaken. In situations such as this, contamination should always be considered possible – not just from the manipulation procedure, but also due to degradation of the source integrity because of the environment in which it has been used.
