Lost radiography source leading to exposure of many personnel

Description of the incident

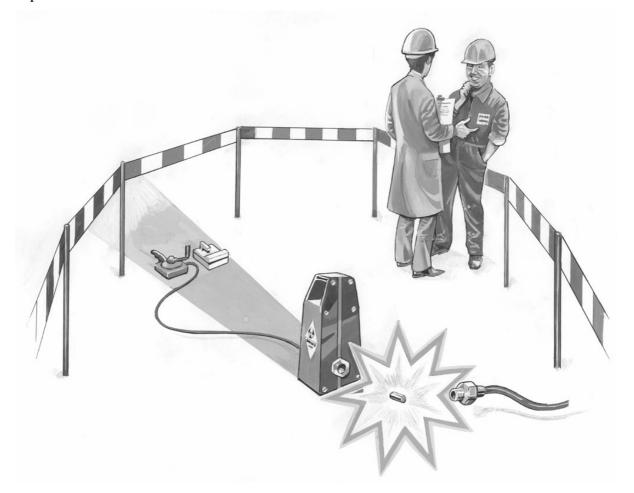
Later investigation showed that the source had become detached, for some unknown reason, and had fallen from the guide tube during dismantling. The dose rate monitor had not been used correctly to ascertain that the source had fully returned to its container. The noted drop in dose rates at the winding position had arisen because the source had become detached from the drive cable close to the source container, which shielded the dose rate meter from direct radiation from the source.

Source became detached but shielded by container during winding in operation

- 1. Sources becoming detached are usually caused by wear in the joint between the source pigtail and the windout cable. It is vital that the level of wear is monitored and repairs carried out as necessary, along with annual servicing of the container and windout gear.
- 2. The monitor should have been used to fully check around the container to verify the source was in the safe position.
- 3. Monitoring should have been carried out when the container was returned to the source storage location. This would have identified the source as missing a lot sooner as the dose rate would have been much lower than normal.

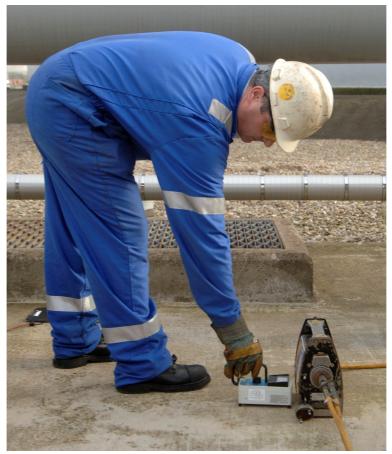
Monitoring close to source container to ensure that source is fully shielded
