Report from a UK incident

Gamma radiography source stolen and dumped in canal

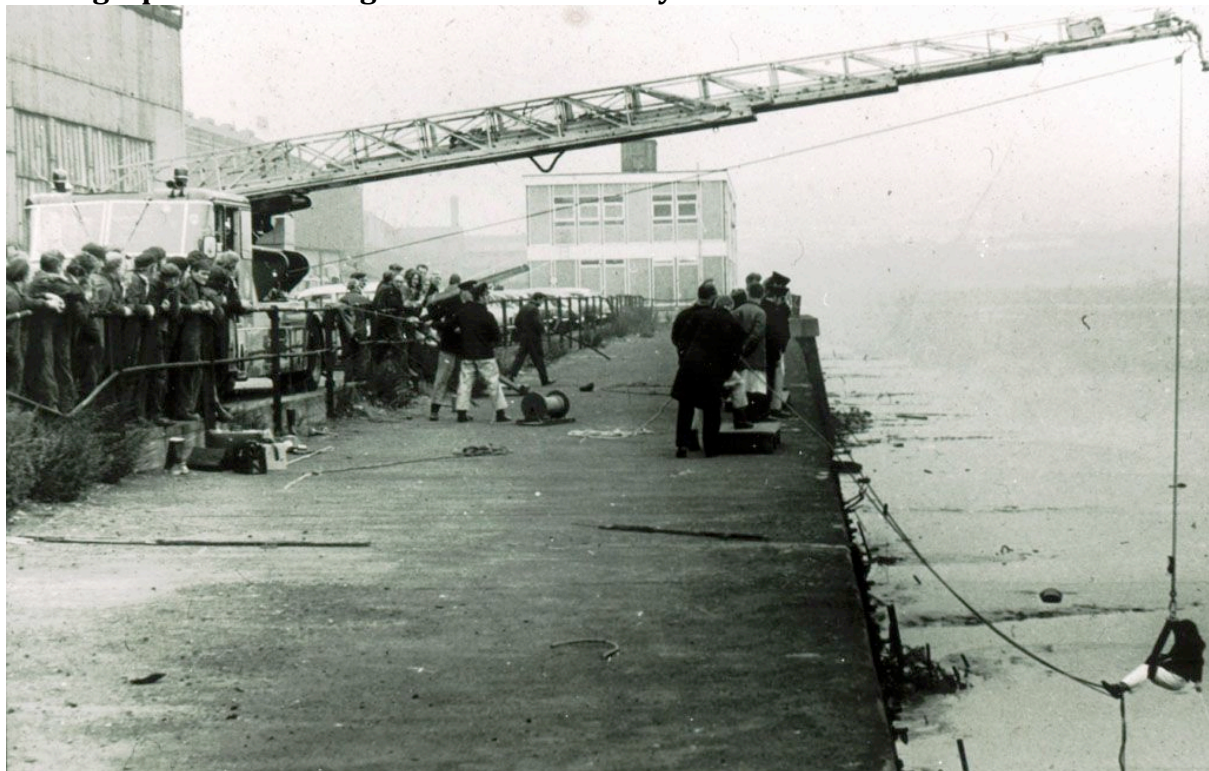
A special radiation detector, capable of operating under water, had to be constructed. The recovery operation lasted 2 days in very bad weather conditions. Initial attempts at dredging for the source were unsuccessful; it was eventually recovered by a Police diver using the underwater radiation detector and handling equipment.

Photograph taken during the source recovery
