Report from a UK incident

Borehole logging – detached gamma source during source loading offshore

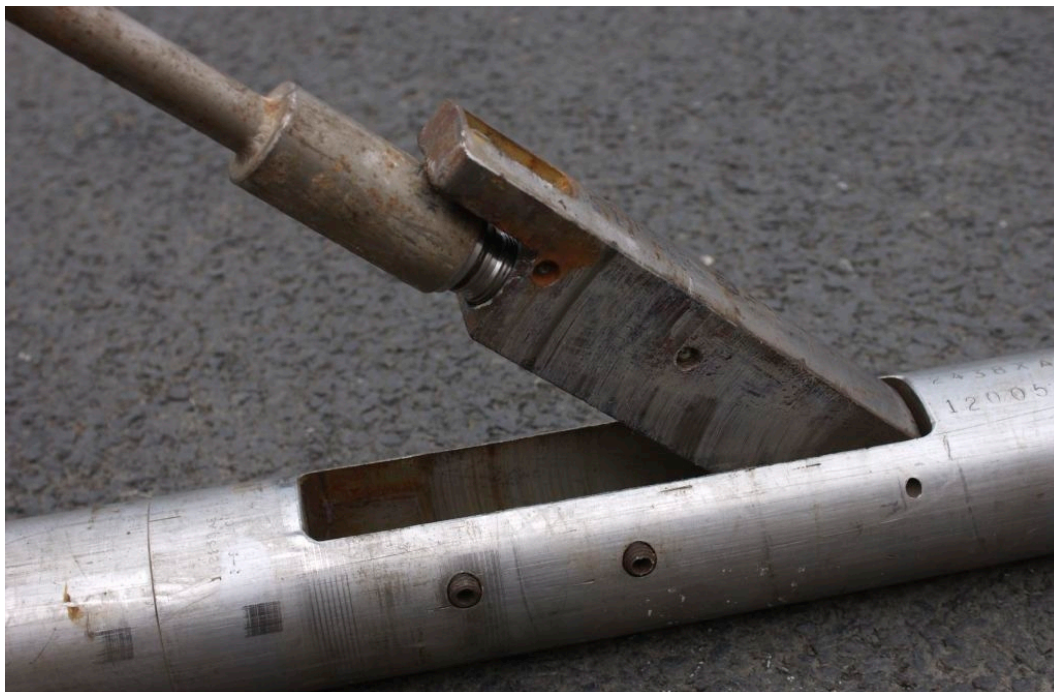
On an offshore oil exploration installation, 57 GBq caesium-137 source was being loaded into a logging tool for insertion down a well. During this operation, the source was unintentionally removed from the device – it was still attached to the source handling tool as it was being withdrawn. The source then became detached from the handling tool and rolled along the floor until coming to rest under some metal pipes.

Photograph of source being loaded into a borehole logging tool

It was subsequently discovered that incorrect handling procedures were commonly used for loading the source into the equipment, although these were not in fact the reason for this particular incident. Nevertheless, the operating procedures were revised, the design of the equipment design was reviewed, and additional radiological safety training provided.
