Report from a UK incident

Incident in an NDT X-ray enclosure due to safety systems being disabled

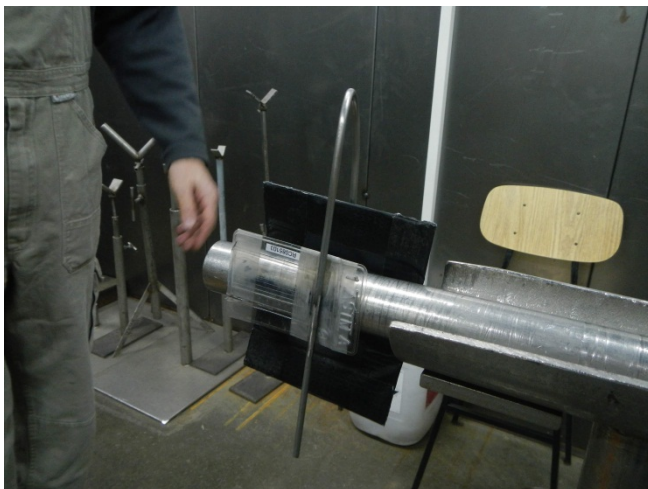
Two workers were undertaking X-ray radiography in an NDT enclosure: an inexperienced worker (started a few months before the incident) and his more experienced colleague. The inexperienced worker, returning from a break, entered the enclosure to change a film while an exposure was taking place. The entrance to the enclosure was fitted with safety switches, but these did not terminate the exposure when he entered, nor did he notice that the exposure warning lights were on. His more experienced colleague was not present at the control panel but was preparing chemicals in the darkroom.

The photographs below show the changing of the radiographic film (left), and the switchbox containing the interlock override switch (right).

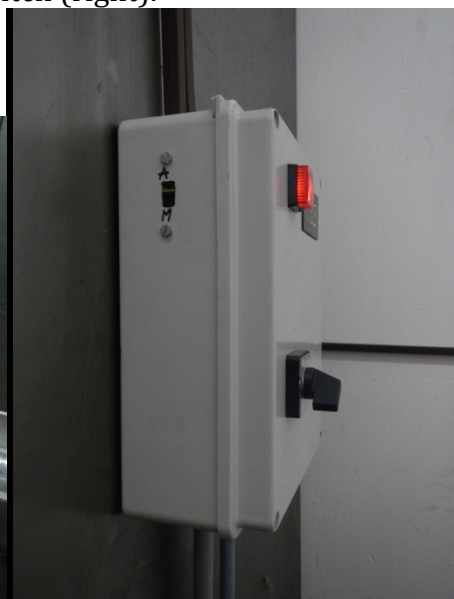
Investigation of the incident showed that the safety system had been disabled during the incident. The safety system was equipped with an override switch but this could only be accessed using a screwdriver. It was revealed that some of the operators were using the switch to disable the safety system to speed up the work. Apparently the last operator that disabled the system did not switch it back on at the end of his shift. The safety system was not checked at the start of the work, despite this being required by the Company rules.

- The safety system override switch was removed. Such switches should not normally be required. If they are fitted, access to the override system must be tightly controlled.
- A check list of tasks to be performed before start of work was introduced.
- A safety briefing related to the incident was conducted with all workers.
- Electronic dosimeters will be provided immediately for every new worker. Such dosimeters provide an important extra layer of safety, should the other safety systems fail.
- Internal training and supervision were both increased.
