Report from a UK incident

Incident in a brewery due to the installation of a new X-ray tube in a fill-level gauge

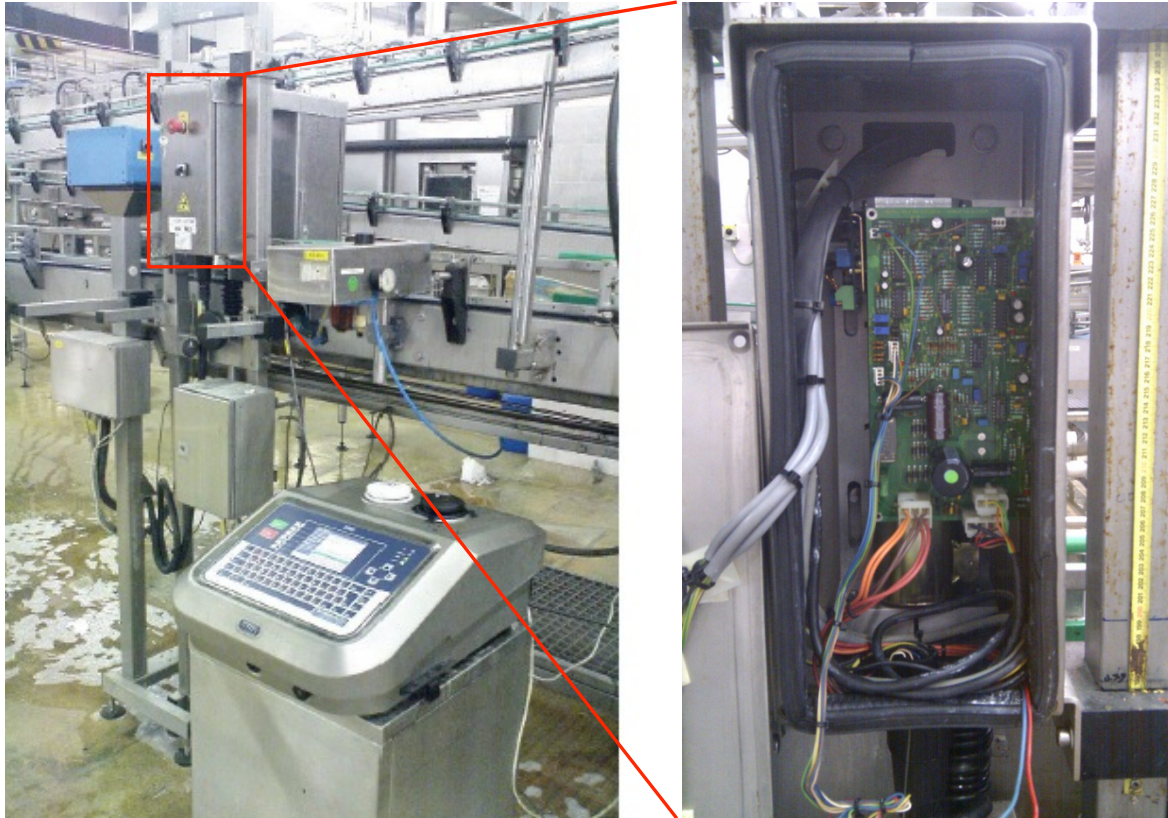
Using a dose rate meter he could measure almost no reading at the detector position, but there was a significant dose rate at the position he was occupying. He switched the unit off immediately and contacted radiation protection experts. Further investigations showed that the tube had been mounted incorrectly (by the suppliers) on the circuit board, such that the tube window was facing a wrong direction (towards the worker instead of towards the line).

Photographs: the original gauging system on the can filling line (left), and inside the gauge cabinet (right): the X-ray tube is mounted on the rear of the circuit board.

- A programme of workplace monitoring was introduced after the incident and personal dosimeters for maintenance staff are under consideration.
- Due to an old age and unavailability of spare parts the level gauge in question was replaced by a new one.
- Basic radiation protection training for all workers working in vicinity of sources of ionising radiation was organised after the incident.
