Industrial radiography: hand injury from exposure to X-ray beam

Description of the incident

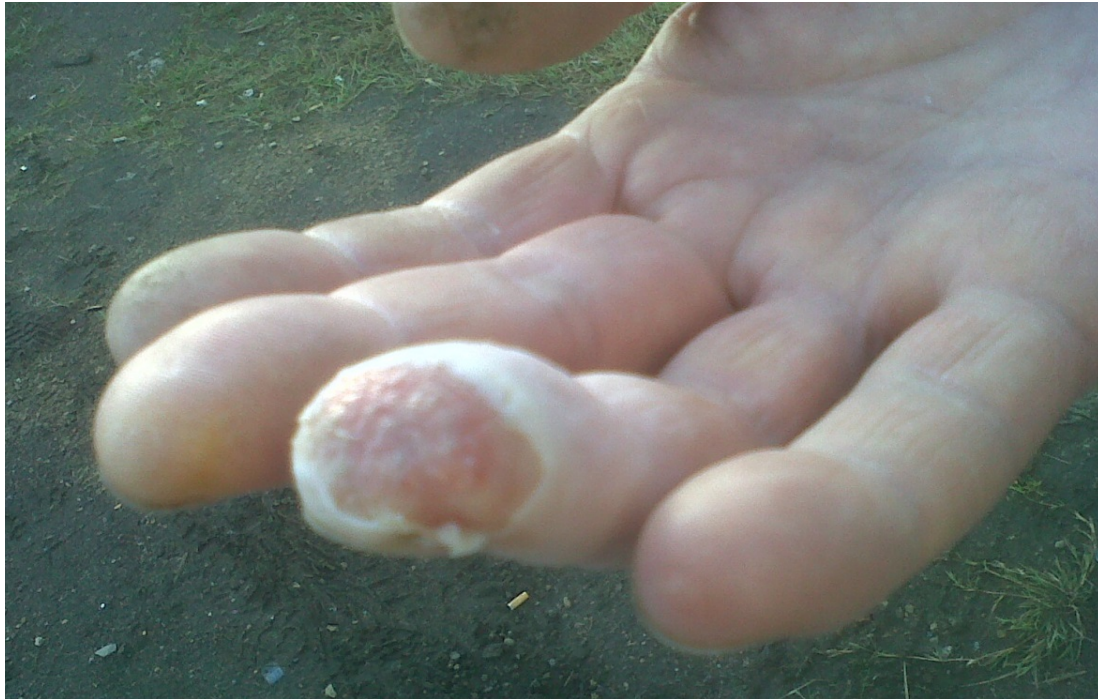
No immediate investigation was carried out: the incident was reported 3 weeks later when the radiographer informed the Company of radiation burns on the ends of his fingers (see photograph below).

It was estimated that the exposure to the radiographer's fingers was approximately 23 Sv (based on a 2 second exposure to the beam).

The radiographer suffered severe tissue damage to fingers on his right hand (see photograph). He did have surgery, but his fingers remain numb, with occasional tingling, although he has now been able to return to work.

- Industrial radiography uses high output sources. Even very short exposures to the main X-ray beam can produce radiation injuries. Safety and warning systems should never be disconnected or overridden unless other precautions can be put in place to maintain the same overall level of radiation safety.
- Industrial radiography safety systems should be regularly tested; however the testing methods should be subject to a proper risk assessment process, in consultation with a Radiation Protection Expert (RPE). Such an assessment would have highlighted the potential dangers of disconnecting the installed safety systems. In this case, it would have been relatively simple to arrange for alternative safety systems to prevent access to the enclosure during testing.

- Key-controlled X-ray control panels are an important safety feature. In this case, the key was left unattended in the control panel, even though the working instructions required it to be removed. In the subsequent investigation this was found to be a common practice.
- A separate independent safety system (in this case, an installed “gamma alarm” radiation detector) prevented the dose from being much higher. Personal electronic alarms/dosemeters provide a similar function, and should be considered for all industrial radiographers.
- There were no specific safe working procedures for testing the mobile safety systems, and there were no provisions for ensuring that this task was properly supervised.
