Report from a French incident**Exposure due to a mobile freight fluoroscopy device****Description of incident**

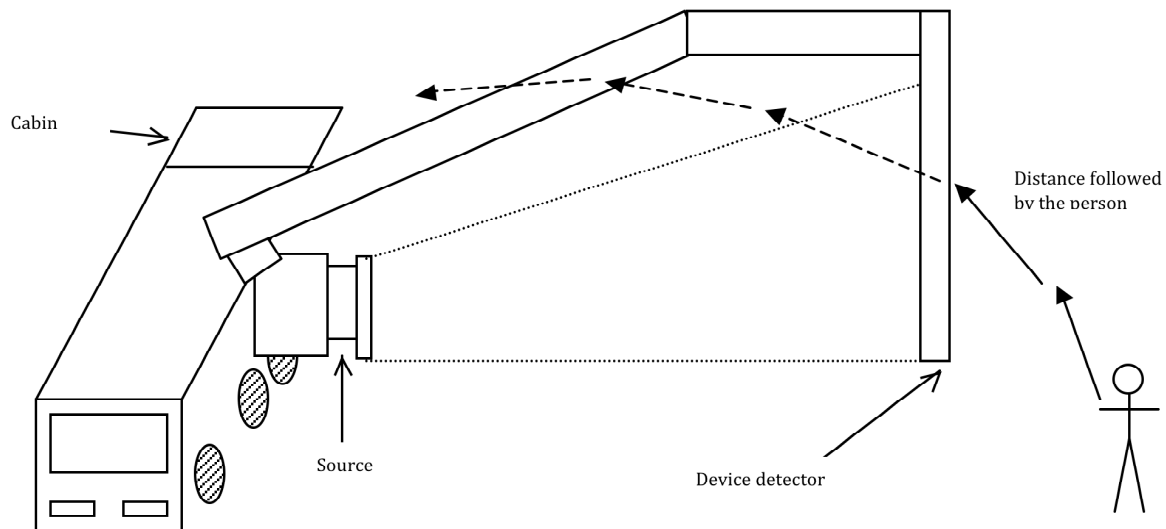
The person followed a path that led them to walk alongside the Mobile-HCV at approximately 3 metres from the device's detector (see diagram), entering the controlled area for an instant. Upon arriving close to the cabin, the person then crossed the light beams delimiting the secure zone, which resulted in the interruption of the X-ray emission. The detector column was shielded, and the person did not cross the direct X-ray beam.

Following the incident, a dose assessment was performed based on the above description (a total of 6 minutes occupancy time). The estimated dose was 0.36 μSv .

Measurements under real operating condition were carried out at various points. In fact, for a point situated 3 metres to the left of the source, the dose rate was 150 $\mu\text{Sv/hr}$, likely to be the result of a slight leak.

- Ensuring that the perimeter of the controlled area is fully demarcated (by physical barriers or light beams), and marked with suitable warning signs (including “do not enter”) at all potential points of entry.
- The above demarcation is only effective if it has been verified, monitored and supervised in order to avoid it being crossed by onlookers or other workers.
- During the operation, an operator should always be present to terminate the exposure in the case of any incidents such as this.
- Audible signals when the device is in operation would draw it to the attention of persons attempting to enter the area.
