Report from a French incident**Deterministic effects to worker's hand during unauthorised density gauge disassembly****Description of Incident**

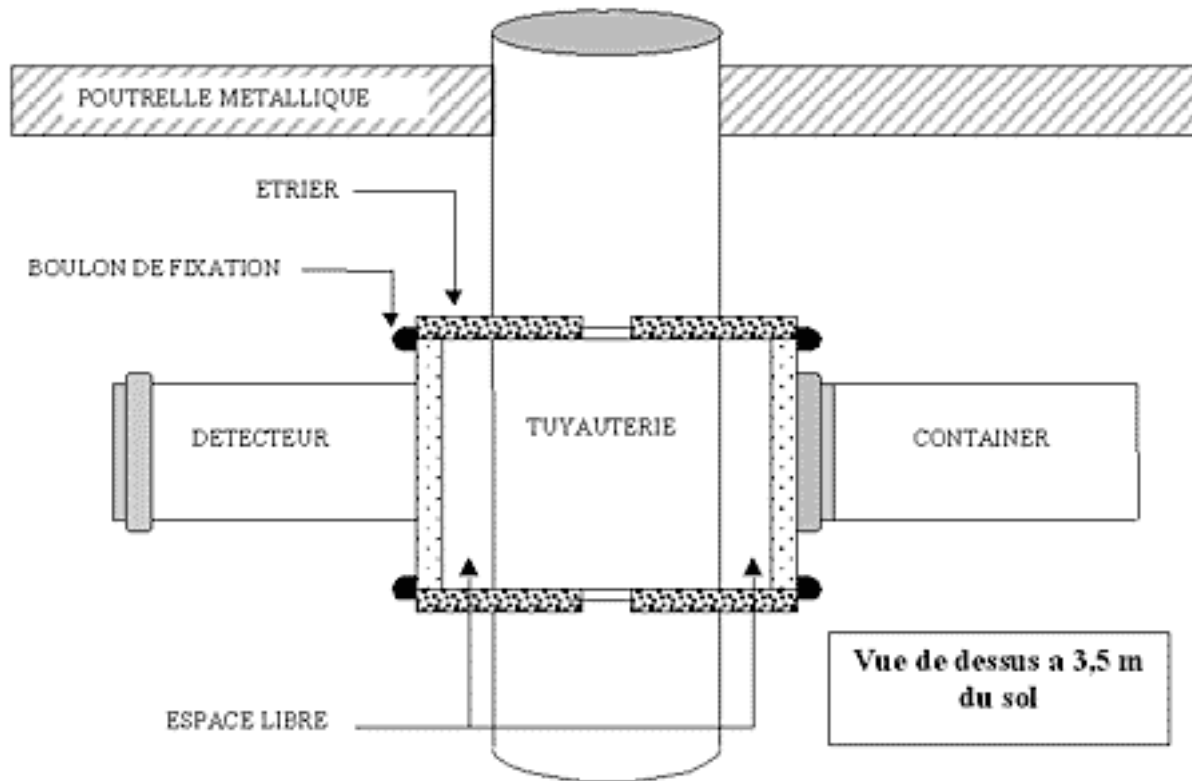
Diagram of the plant

The gauge is located in a noisy and cramped location, on a very hot pipe. It is installed at a height of 3.5 m and is only accessible by means of a ladder. The device is equipped with a radiation warning sign, which is clearly visible at 2 m above the ground. The source details (caesium-137, 7.4 GBq) are written on an engraved plate fastened on the source container.

The installation of the radioactive source in a noisy, congested area, located in an inaccessible place on a very hot pipe, did not facilitate easy maintenance and monitoring, and led to the unfortunate initiative taken by the worker.

Before undertaking any maintenance operation, it is necessary to ensure that the radioactive source is well shielded by using a suitable radiation monitoring instrument. In this example, the worker did not check the dose rate before attempting to clean the device. An electronic alarming dosimeter would have indicated the presence of the source and prevented high doses being received (although this should be used as an additional precaution, and not as a substitute for a dose rate monitor).
