Deterministic injuries to radiographers hand

Description of the incident

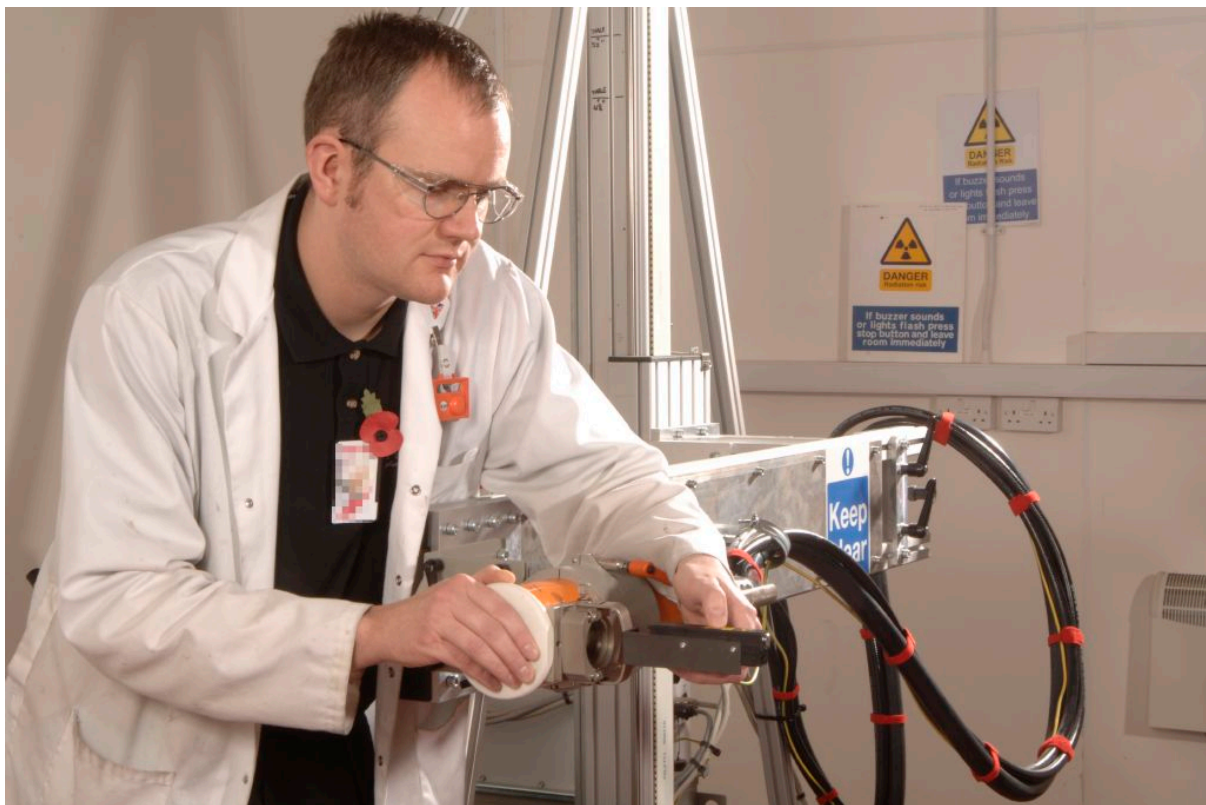
An example of a radiographer setting up an industrial x-ray set
