Report from a UK incident

Dental x-ray set operated continuously

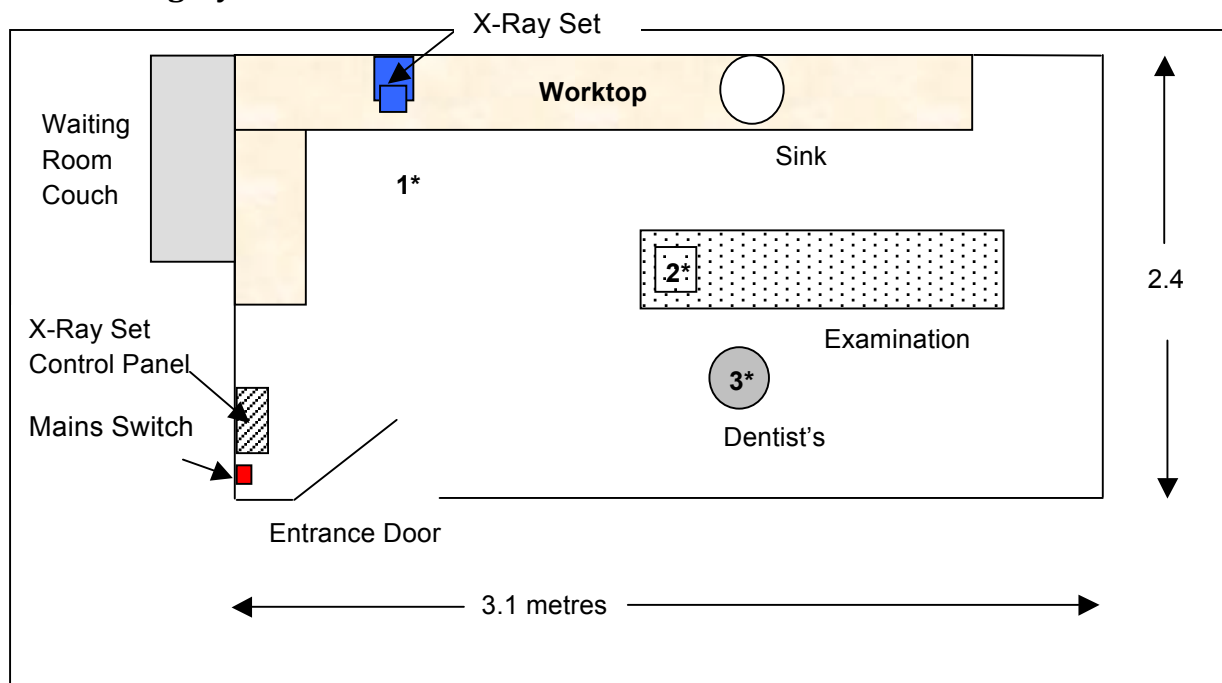
Plan of surgery

In the time that the x-ray set was producing x-rays, the tube was in the position it normally occupied when not being used, i.e. close to the wall opposite the entrance to the surgery, with the collimator directed either vertically downwards, or horizontally towards the wall separating the surgery from the waiting room. As all the walls in the surgery are of solid construction, no-one outside the surgery will have been exposed to the main beam. It is also likely that persons present inside the surgery would only have been exposed to scattered radiation.

As part of the investigation, doses to the five members of staff and two patients present at the practice during the time that x-rays were being generated were estimated using the levels of scattered radiation near to the x-ray set during operation and likely maximum occupancy times. These are given below:

Person	Maximum dose received (μSv)
<i>Present in same surgery as faulty x-ray set</i>	
Dental nurse (position 1 in diagram)	19
Dentist (position 3 in diagram)	3
Patient (position 2 in diagram)	6
<i>Other persons elsewhere in practice building</i>	6
Practice Manager, working in adjacent office	6
Dentist working in adjacent surgery	2
Dental nurse working in adjacent surgery	<1
Patient sitting in adjacent waiting room
