Report from a UK incident

Baggage x-ray inspection unit: engineers exposed during maintenance**Description of the incident**

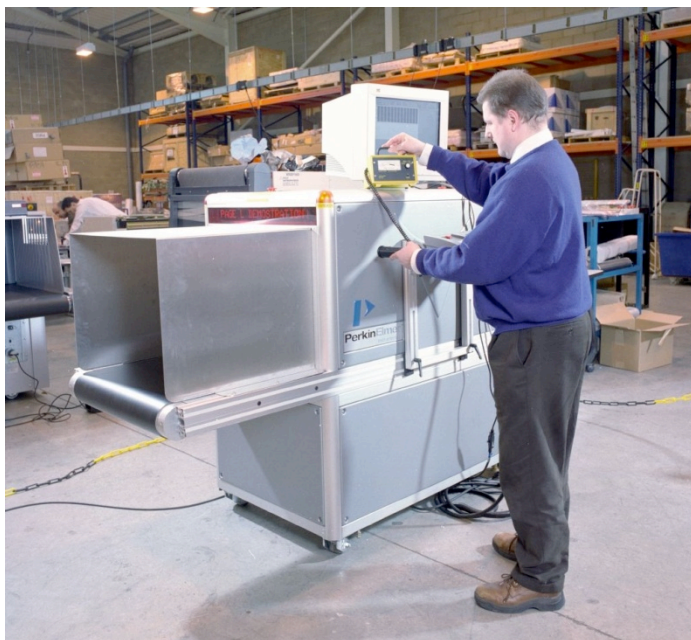
Example of a radiation survey around a baggage inspection unit after maintenance

A radiation survey should always be carried out following any maintenance, and the results should be recorded.
