Laboratory incidents due to delivery of higher than expected activity: Phosphorus-32 and Phosphorus-33

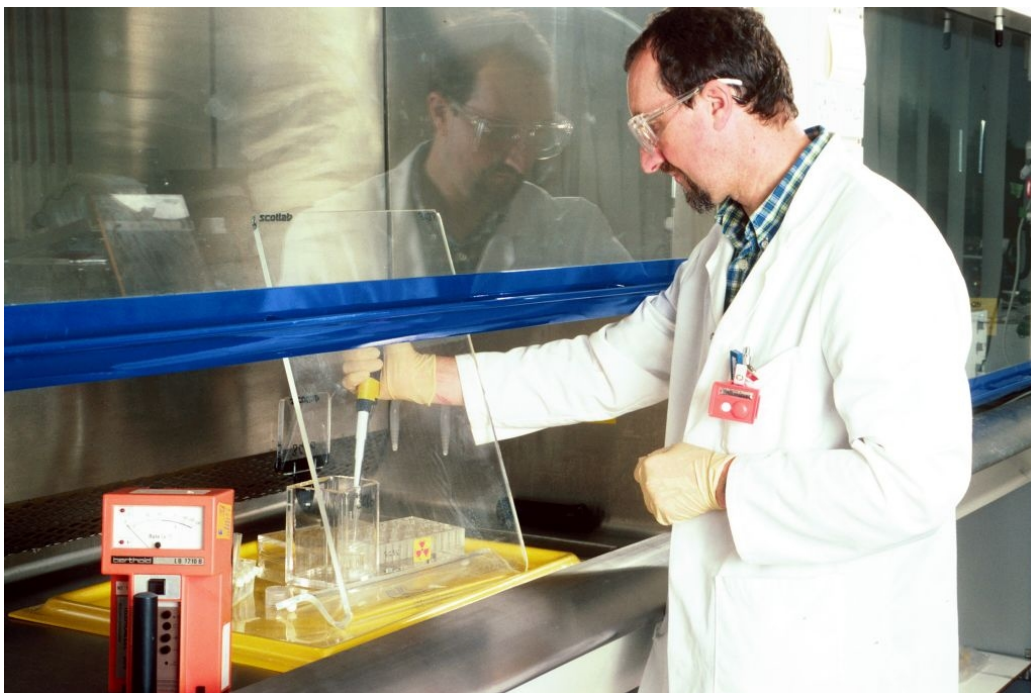
An example of a researcher dispensing a phosphorous-32 solution
